# Manhole Inspection Summary

Manhole # S05YY1006MH

Insp Date: **9/25/06 1:07 PM**

**Location** Address: **3203 GLEN AVE**

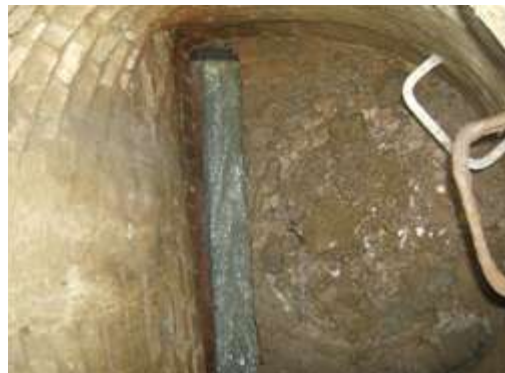
Top View

Adjustment and Barrel infiltration.  
Corroded steps. Evidence of surcharge -  
Bench debris.

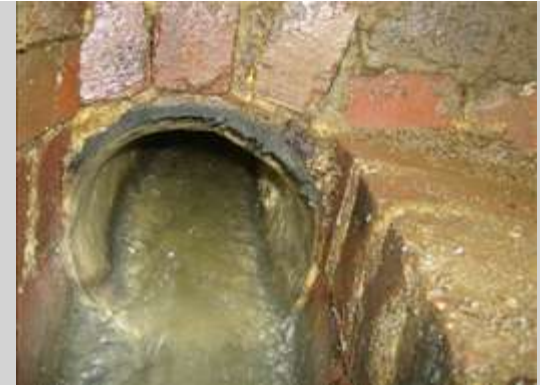
### 8 in. Circular Gravity Sewer Pipe Out @ 12 O'Clock

Pipe Material: **Unknown** ☒ Pipe Lined

Infiltration: **Evidence** Pipe Seal Cond: **Unknown**

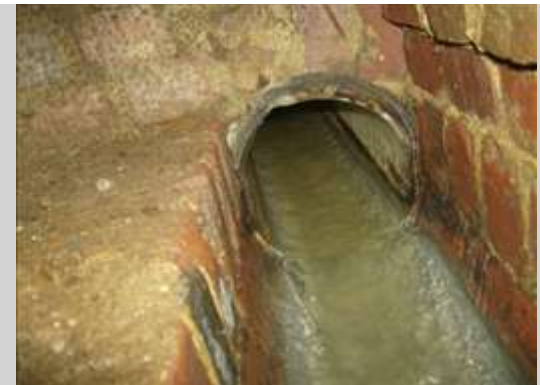
### 8 in. Circular Gravity Sewer Pipe In @ 6 O'Clock

Pipe Material: **Unknown** ☒ Pipe Lined

Infiltration: **Evidence** Pipe Seal Cond: **Unknown**
